Mount Coffee Hydro Power Plant

Rehabilitation, reconstruction and upgrade

Owner's Engineer for Rehabilitation of the Mount Coffee Hydro-power Project

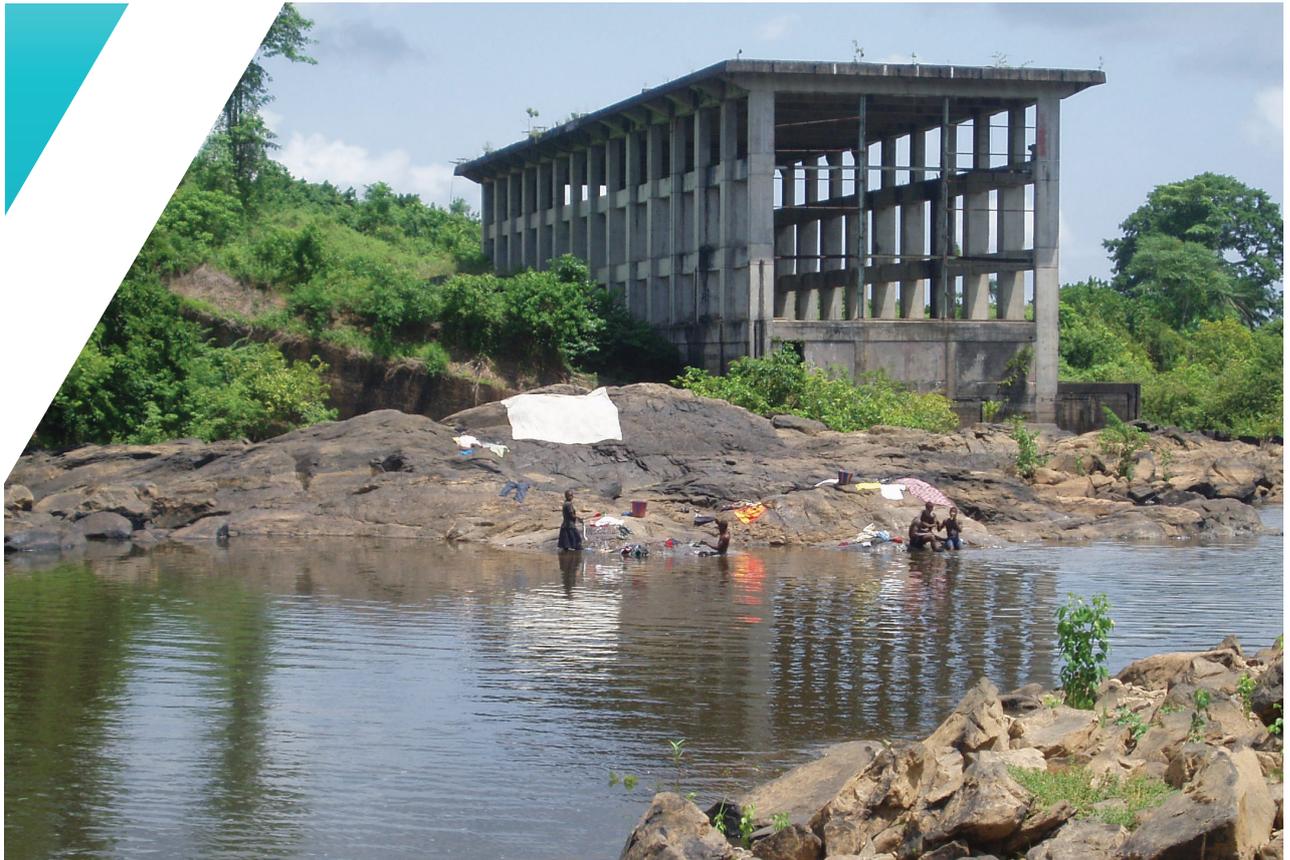
Powerhouse | Photo: Olof Skuncke, Multiconsult

The first representatives from NFJV arrived at the Mt. Coffee plant in 2013 with the assignment to analyse the condition of the structures to define the necessary works to enable re-start of power generation in December 2015, and increase the capacity of the plant as much as practically possible. The members found a skeleton of a powerhouse almost overgrown by the jungle.

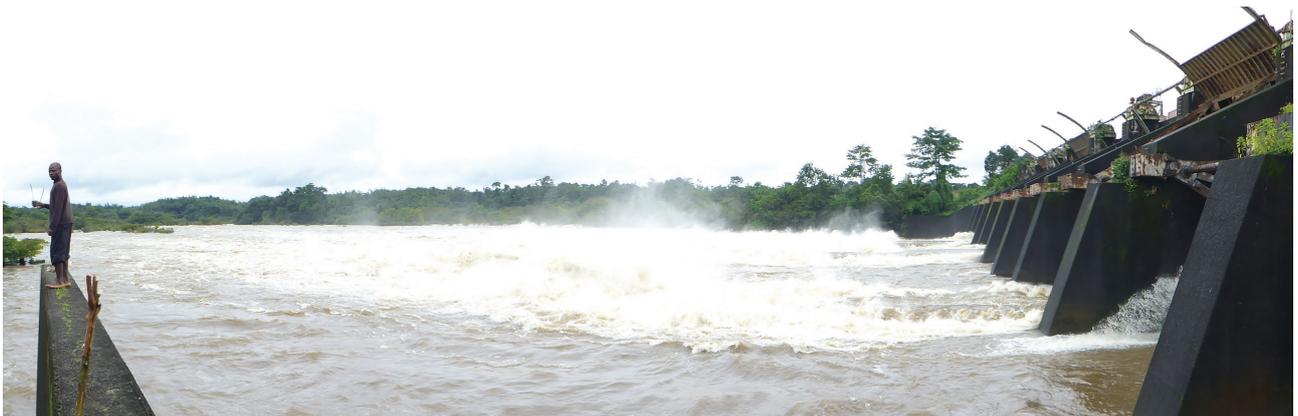
Spillway | Photo: Anders Tørklep, Multiconsult
